Forecast, Monitor, Adapt

A Multi-Agency Effort to Protect People during Postfire Debris Flows

CITATION: Rengers, F.K., et al., 2025, Forecast, monitor, adapt: A multi-agency effort to protect people during postfire debris flows: GSA Today, v. 35, no. 8, p. 16–21, <https://doi.org/10.1130/GSATG611A.1>.

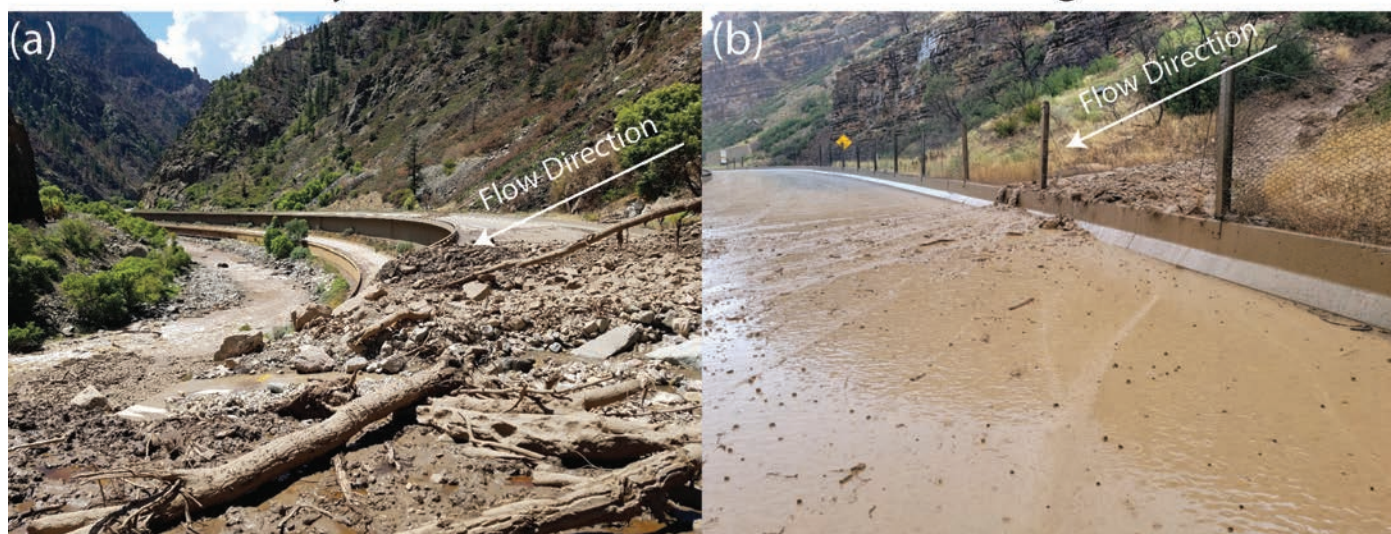
Figure 4. Differences in flow size from the first to third year after the wildfire. (A) A debris flow during the first postfire summer (2021) depositing material on both east-bound and west-bound highway lanes, as well as in the Colorado River. (B) A sediment-laden flow during the third year after the fire (2023) depositing material behind a concrete barrier with minor mud on the highway. (Photo credits: Colorado Department of Transportation).
